Manhole Inspection Summary

Manhole # S37E__010MH

Location Address: **rear 500 e lexington st**

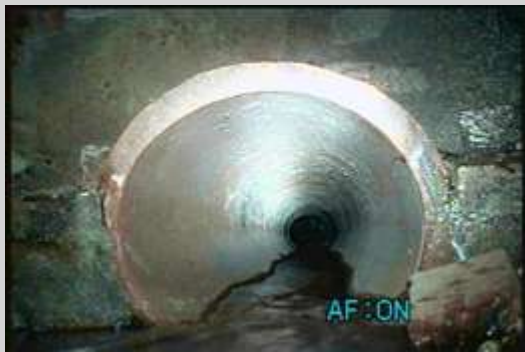
12 O'Clock Outflow

Pipe Height: 0 (in.) Direct

Pipe Material: **Clay** ☐ Pipe Lined

Invert Depth: **13.05** (ft.) Flow Characteristics: **Fast**

Deposits: ☒ None ☐ Mud ☐ Sludge ☐ Debris ☐ Grease

Infiltration: **None** Pipe Seal Cond: **Unknown**

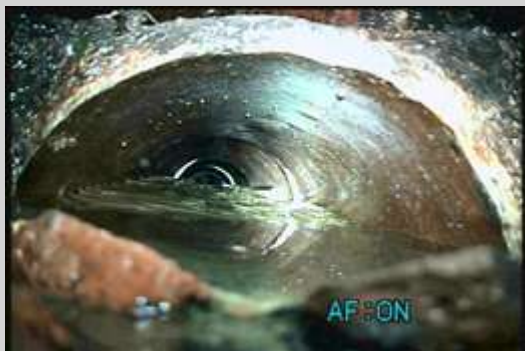
3 O'Clock Inflow

Pipe Height: 0 (in.) Direct

Pipe Material: **Clay** ☐ Pipe Lined

Invert Depth: **12.70** (ft.) Flow Characteristics: **Slow**

Deposits: ☒ None ☐ Mud ☐ Sludge ☐ Debris ☐ Grease

Infiltration: **None** Pipe Seal Cond: **Unknown**

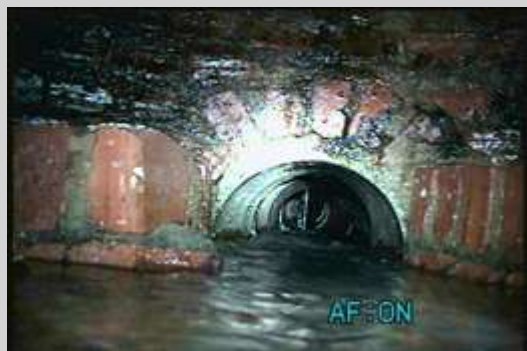
6 O'Clock Inflow

Pipe Height: **0** (in.) Direct

Pipe Material: **Clay** ☐ Pipe Lined

Infiltration: **None** Pipe Seal Cond: **Unknown**
